**Flood Control Project Maintenance
Levee Inspections**

Fall 2018 Levee Maintenance Deficiency Summary Report

Sacramento River Basin

**Flood Control Project Maintenance
Levee Inspections****LMA District Cover Sheet****Fall 2018 Levee Inspection Results****Reclamation District No. 2035 Conaway**

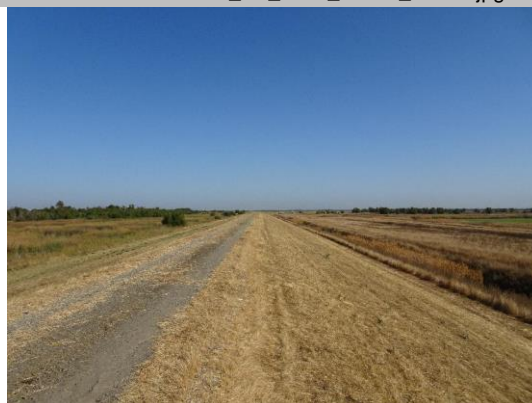
Photo 3 of 3 : UCIP_FA_2018_53430_75935.jpg

LM Start	0.81	Rating **	M	Issue No.	974 (cont)
LM End	0.81	Issue Type +	En	Location *

View along the levee crown looking approximately north. The WS of the levee is on the left. The LS is on the right.
